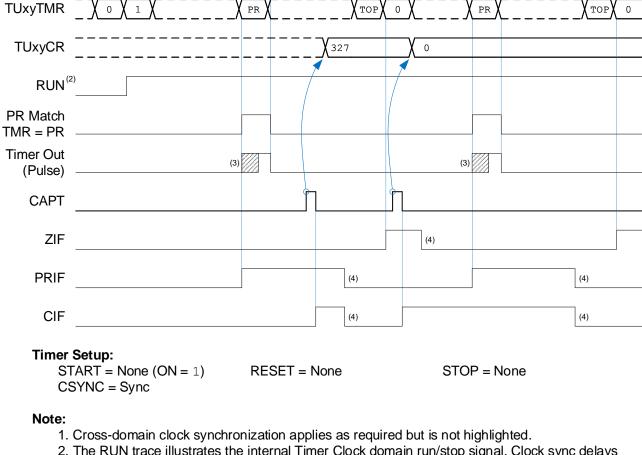
- 2. The RUN trace illustrates the internal Timer Clock domain run/stop signal. Clock sync delays apply before the value appears in the RUN SFR bit.
- 3. The uncertainty of the output is due to the prescaler setting.
 - 4. Cleared by software.
