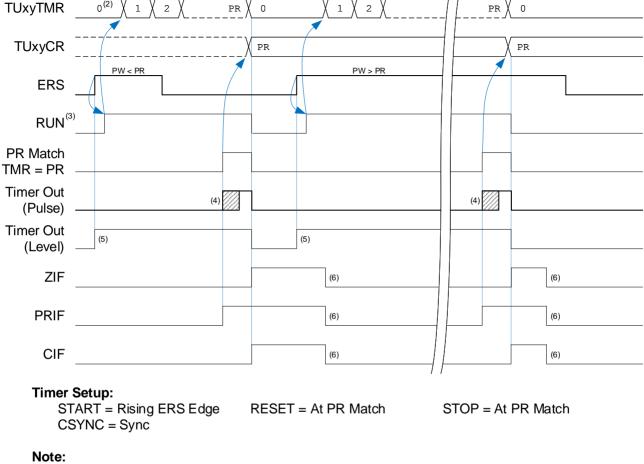
- 1. Cross-domain clock synchronization applies as required but is not highlighted.
- 2. Ensure that TUxyTMR counter is reset to zero by setting CLR command.
- 3. The RUN trace illustrates the internal Timer Clock domain run/stop signal. Clock sync delays apply before the value appears in the RUN SFR bit.
- 4. The uncertainty of the output is due to the prescaler setting. 5. Timer Out (Level) rises along with ERS when START = Rising/Either ERS Edge.
- 6. Cleared by software.
